TRI-SERVICE CONFERENCE ON CORROSION

Topographic Radioscopic Metrology for Corrosion Mapping

John C. Brausch
Wright Laboratory, Materials Directorate
Wright Patterson A.F.B.

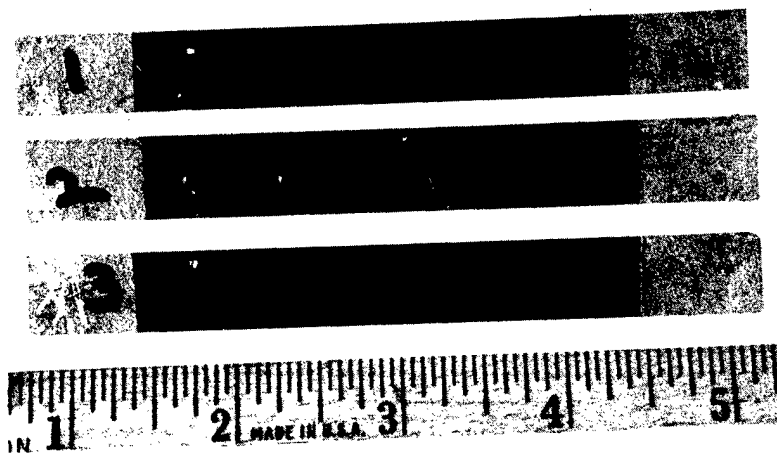
#1	0.03915 in	0.03820 in	0.03710 in	0.03995 in
#2	0.03885 in	0.03800 in	0.03480 in	0.03995 in
#3	0.03255 in	0.03065 in	0.02885 in	0.03995 in

Figure 4. (a) Schematic of machined thickness standards and (b) photograph of standards.

In order to define the calibration curve for relating image intensity to material thickness, thickness standards were manufactured. These standards were milled from 0.040 inch (1.016 mm) 7075-T6 aluminum fuselage skin material to represent material loss values of 2% - 27% (Figure 4). A radiosopic image of these standards was acquired with an exposure of 47 kV and 1.0 mA (Figure 5). The NORAN system captures the intensifier image through 500 frame continuous averaging.

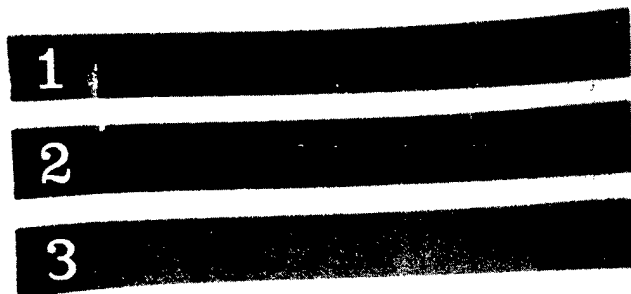
Figure 5. Digitized radioscopic image of thickness standards. Image used to determine the calibration curve relating image intensity and percentage material thickness loss.

Concentric image patterns caused by the intensity gradients of the x-ray beam are eliminated through digital image subtraction of a background image acquired from a standard of uniform base thickness.
